## AMERICA'S HOME INSPECTION REPORT

**1234 Anywhere U.S.A. Dublin, Ohio 43017**

### A.H.I. Inspection Report

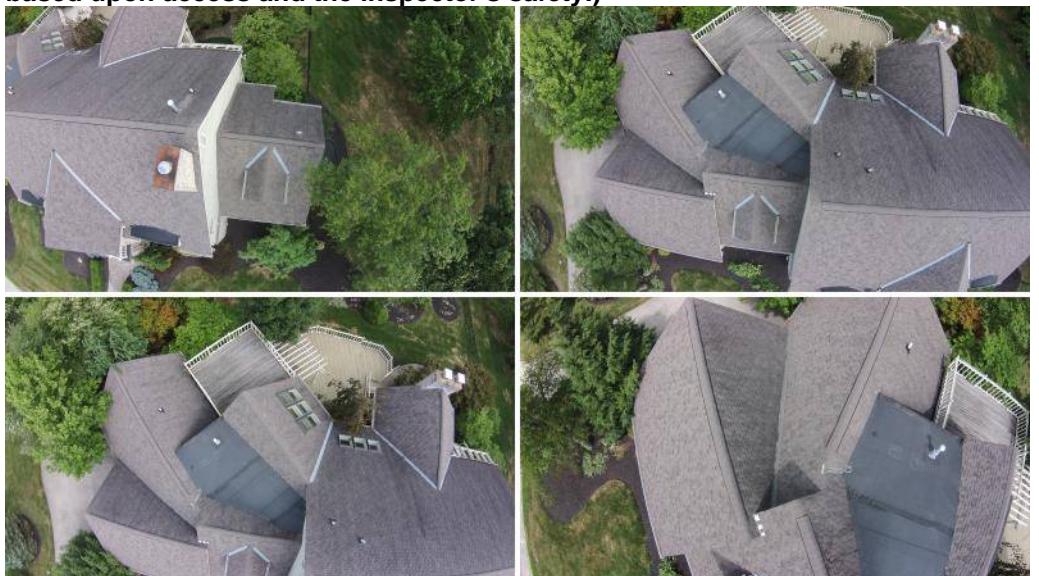
The roof shingles along the front and some areas along the rear side of the house has extensive granulation loss throughout the shingled surface. The granules on the asphalt shingle are what protect the shingle from ultra-violet rays of the sun. Along the rubber roof section I observed areas under the surface that were soft or spongy from likely past water intrusion and below in the ceiling of the loft their also appears to have been past leaks. There were other areas with damage or past leaks along the bathroom upstairs in the bedroom right front. also in the Greatroom ceiling areas were observed.

I observed what appears to be hail damage / Wind along several area's of the roof surface this inspection is not a hail damage assessment however I recommend having the roof looked at further for a second opinion. Contact a qualified roofer of your choice and or check with the seller to have their insurance company follow up. This appears to be the original roof covering I observed several conditions normally observed to determine the life remaining on this roof, A licensed roofing contractor should be called to replace this roof.

A licensed roofing contractor should be called to make further evaluation and repairs as needed.

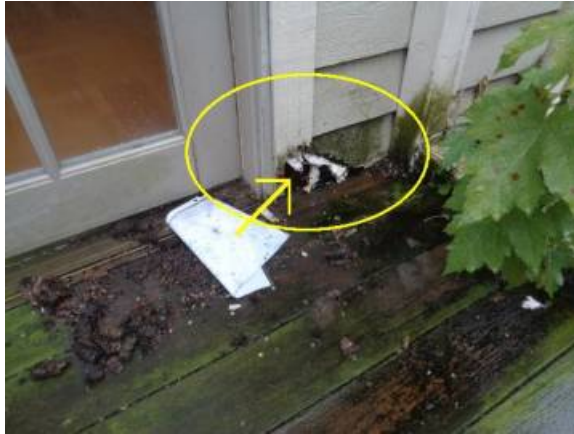
Along the rear upper deck I observed wood rot along the lower siding by the sliding glass door. repairs are needed

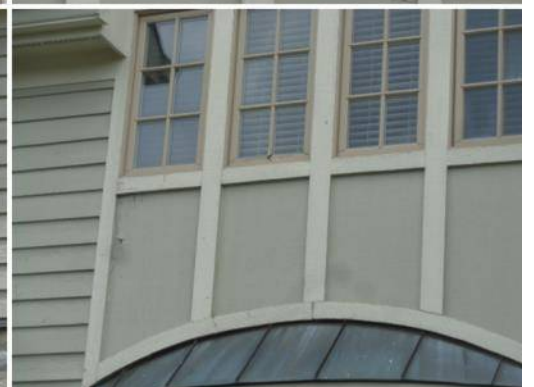
Areas of the trim were weathered and several areas have wood rot concerns maintenance in the way of re staining the surface to help prevent water penetration and damage to the wood.

SUGGESTION: Repair or replacement of all loose or deteriorated trim and/or siding material will help to protect exposed materials from further deterioration.

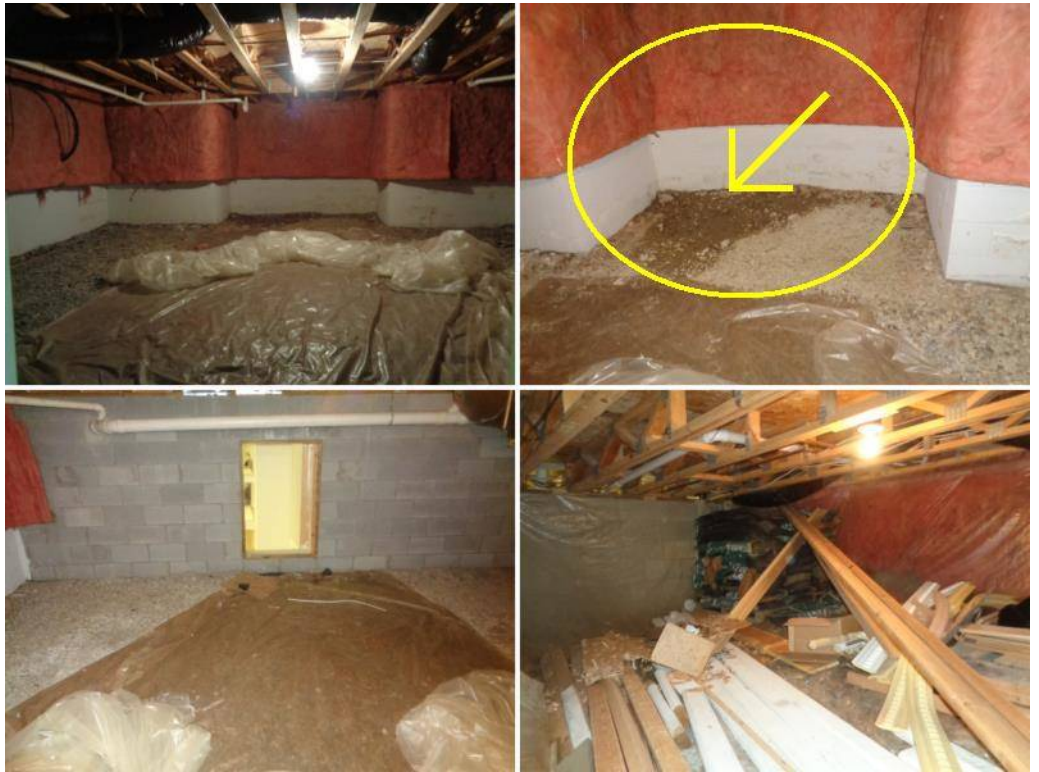
The exterior wall along the EAST side maybe allowing water to enter under heavy rains.  
FYI

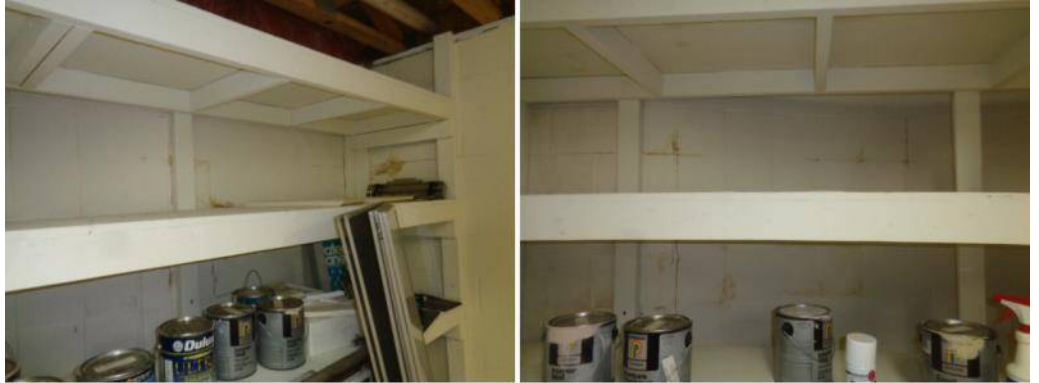
Staining was observed: along the front South wall Water seepage may recur in the future. The best defense against water seepage is good drainage of soils near the foundation wall.

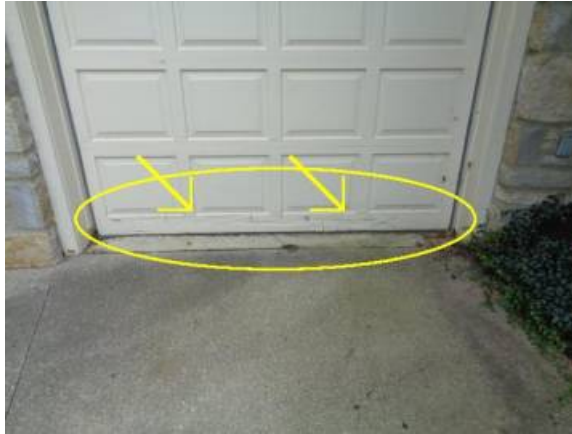
Wood - Wood rot was observed along one door lower panel.

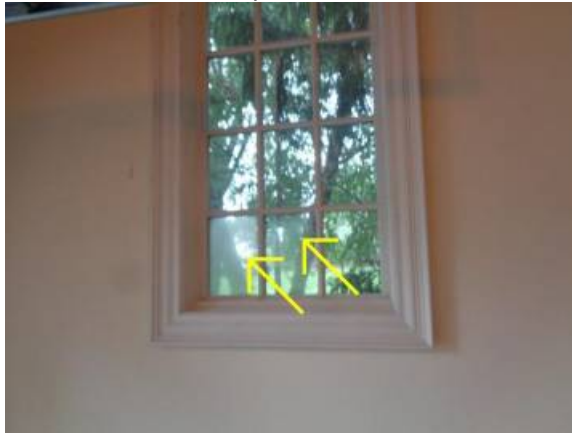
Along the garage one window has a few seal failures which allows moisture to enter between the window panes.

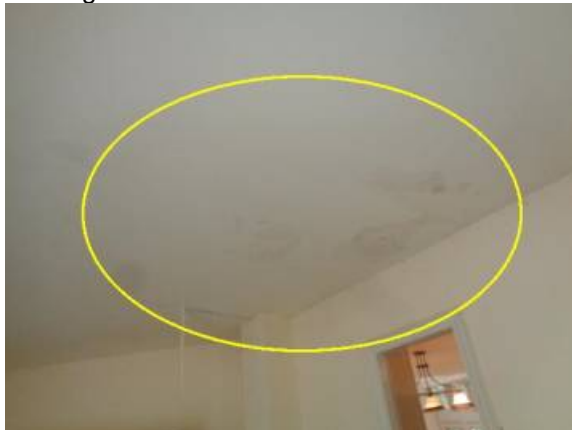
Along the ceiling in the garage there were several areas with what appears to be water staining. FYI

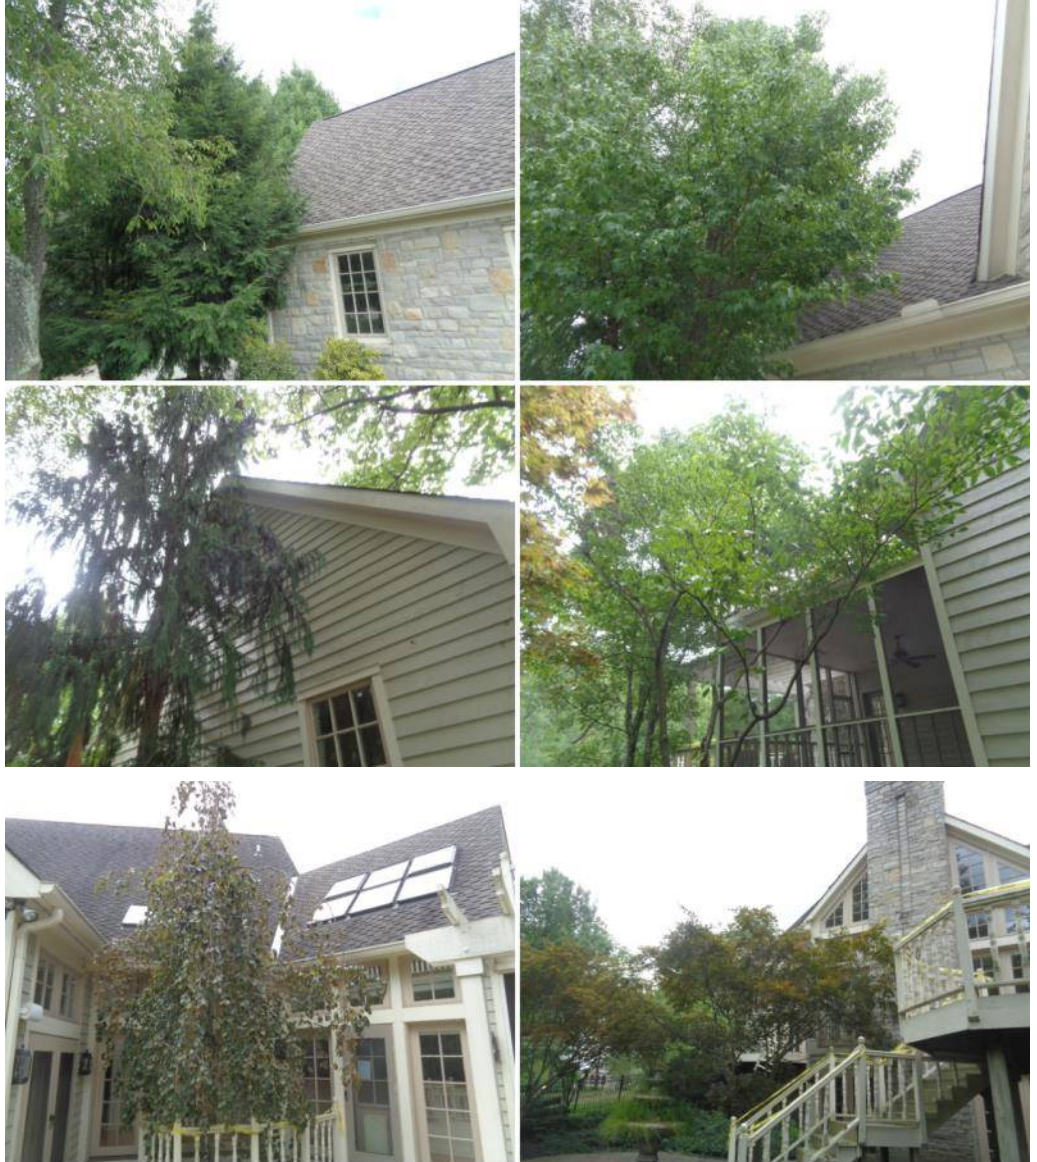
Trim plants away from structure. Tree limbs or bushes contacting or over hanging the structure need to be trimmed back 2 to 3 feet away from the home to prevent damage.

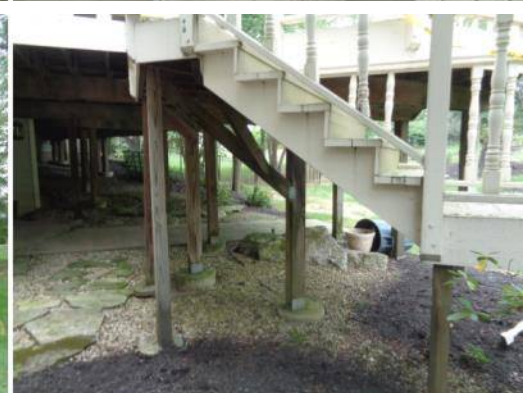
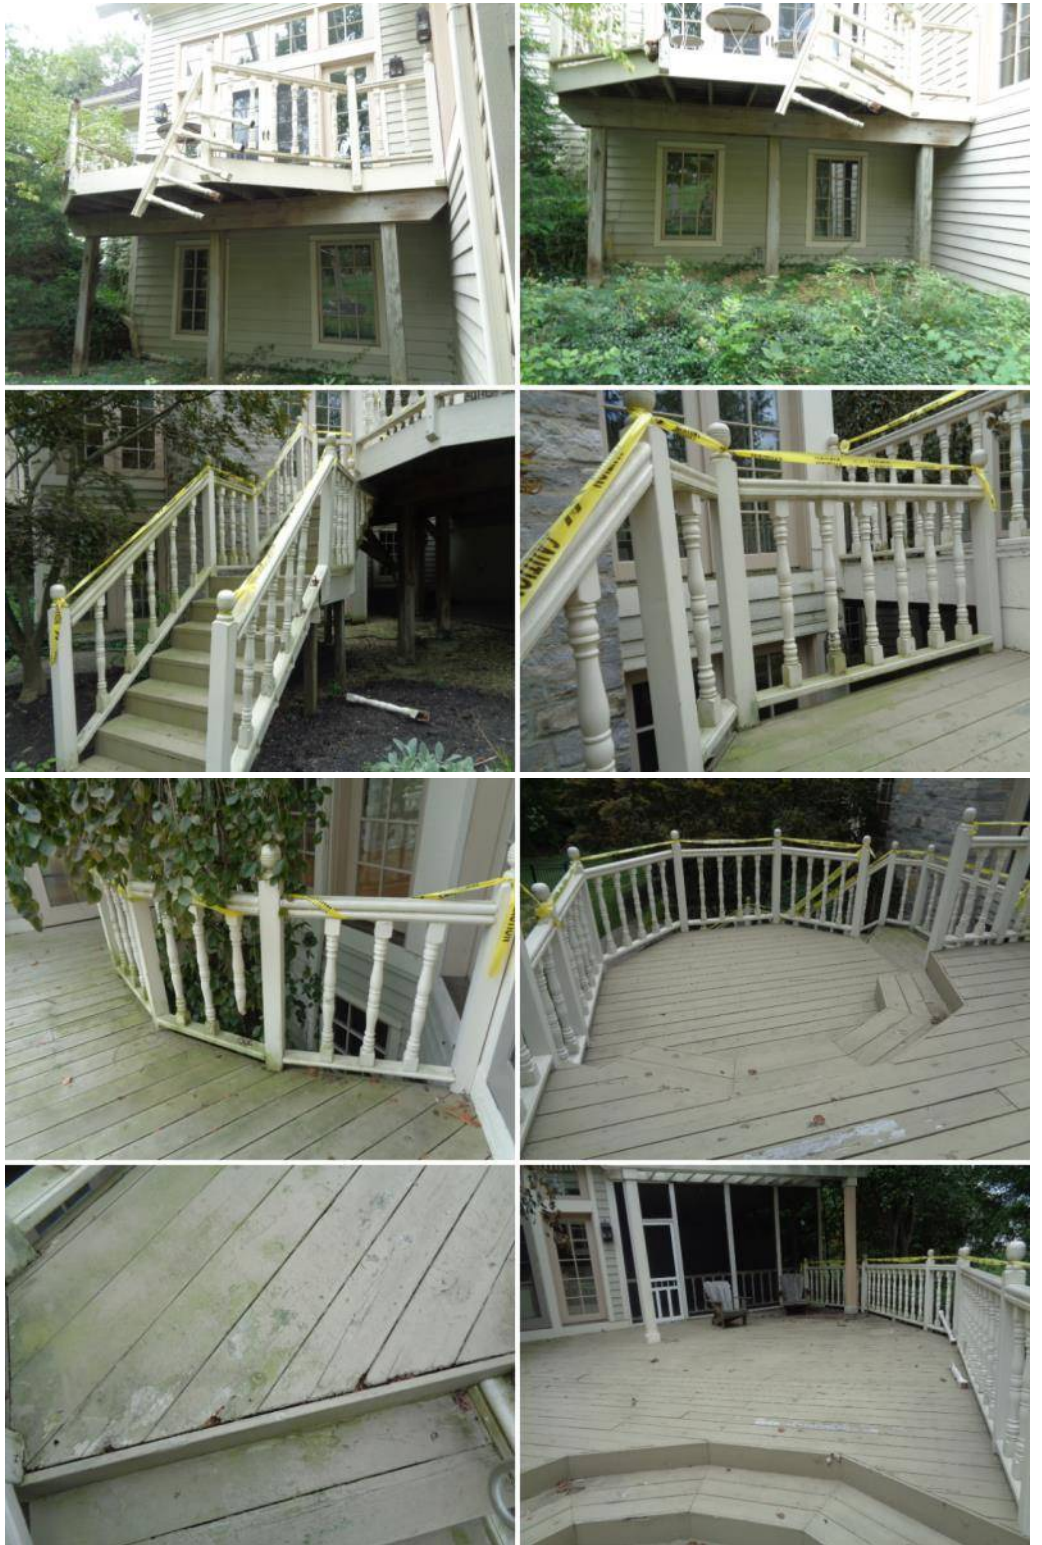
Deterioration noted to areas of the deck surface. The entire railing threw out needs replaced due to the amount of deterioration and unsafe conditions that exist.

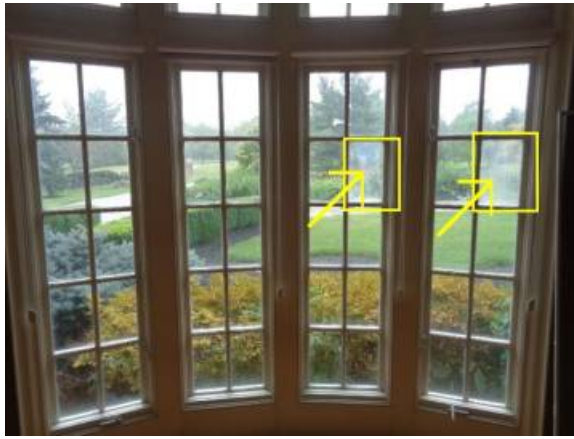
Condensation observed due to failure of seals in insulated glass a tleast 2 windows

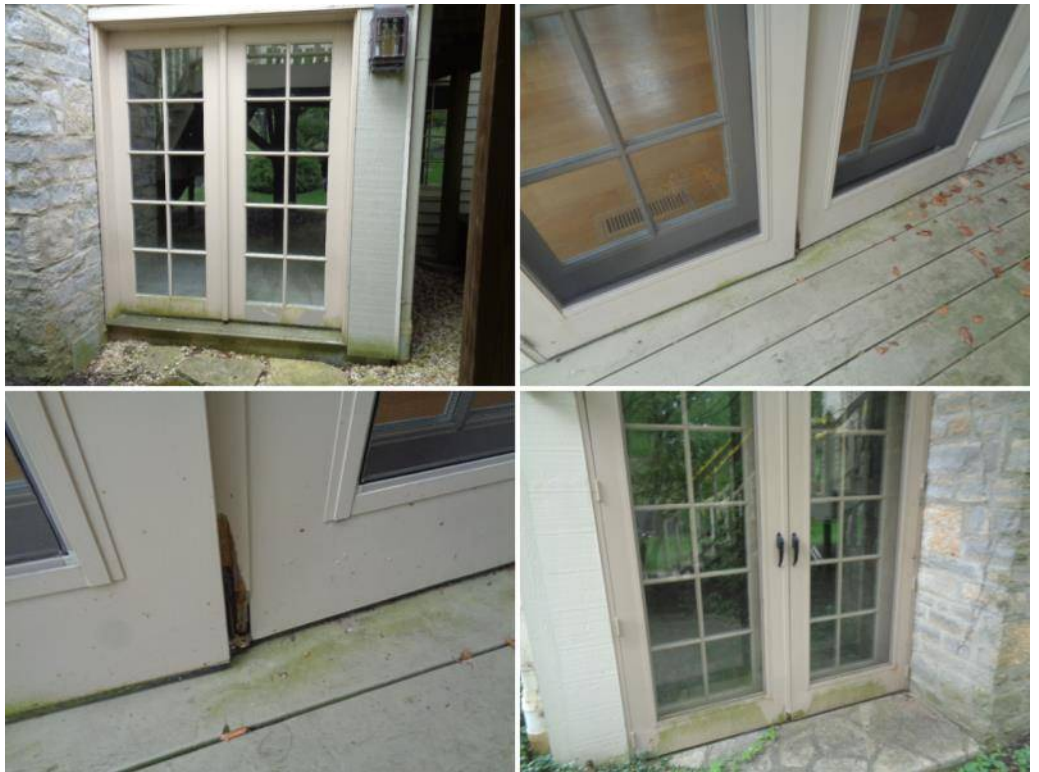
Along the exterior storm doors I observed wear and some wood rot.

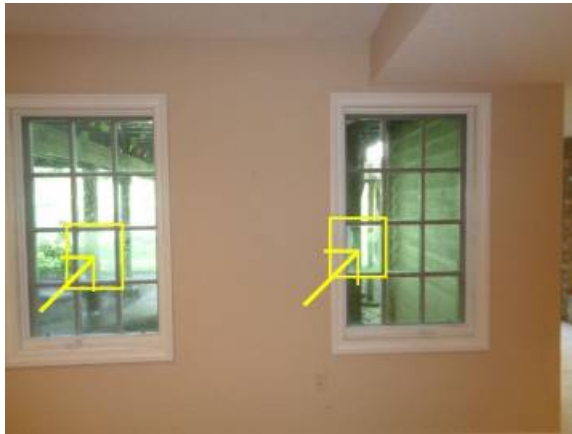
In the lower walkout I observed a few windows with seal failures.

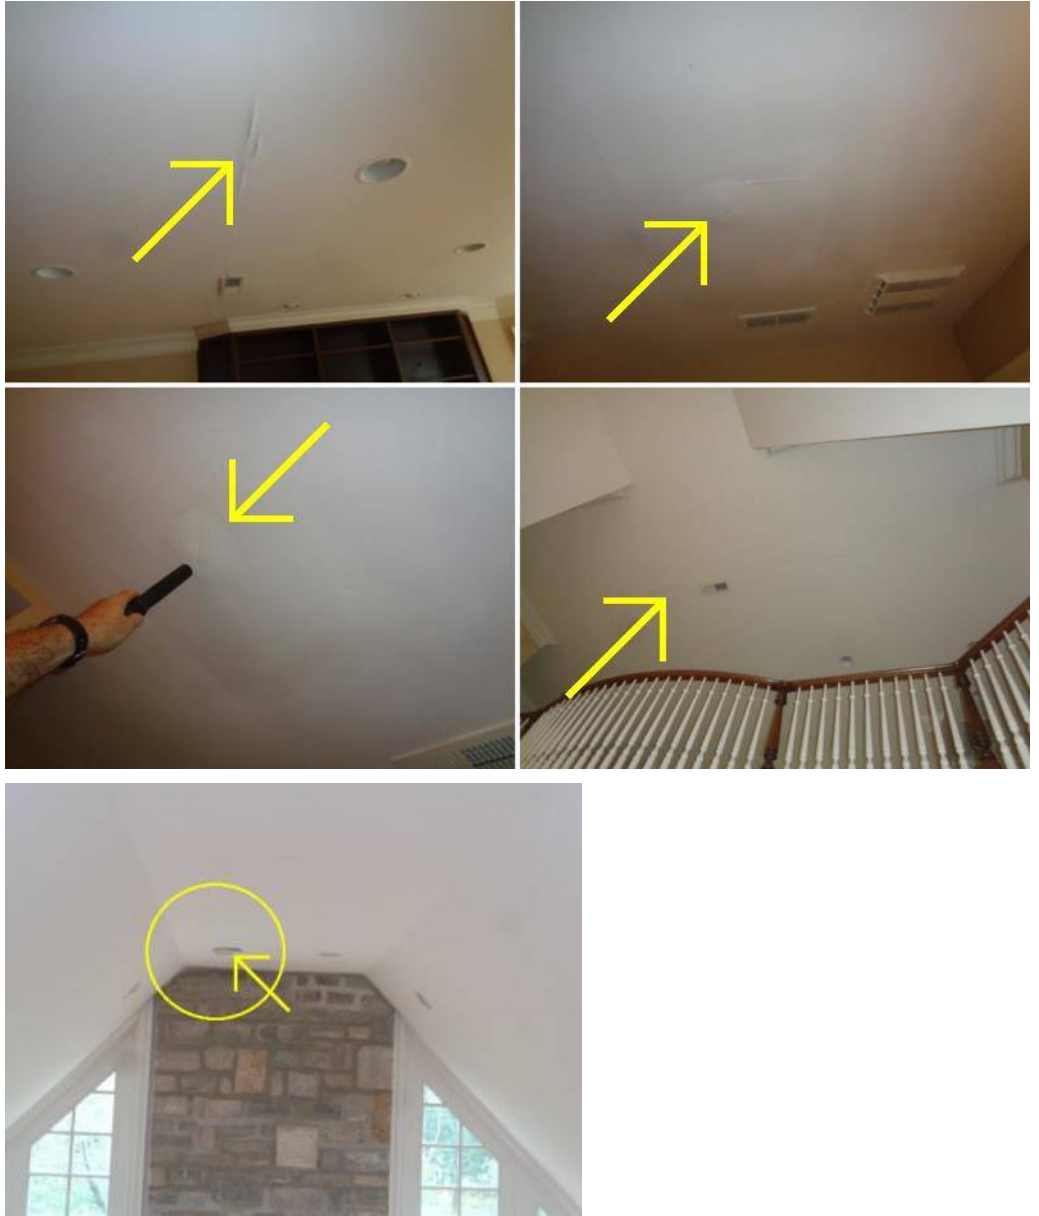
Areas noted with past water leaks. Along the great room 1 can light was loose and needs re secured

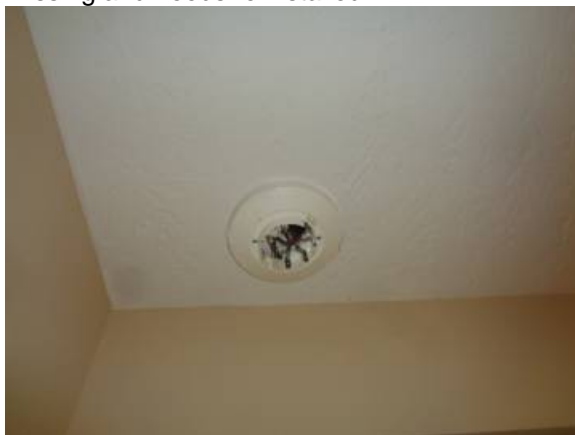
Smoke alarm(s) responded to test button operation , One along the basement was missing and needs re installed.

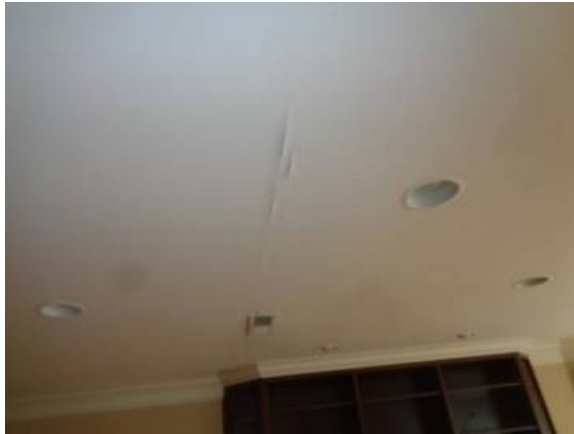
Windows were observed to be operational.  
Drywall General condition appears acceptable  
Drywall - Stains noted PAST leaks from the rubber roof was observed .

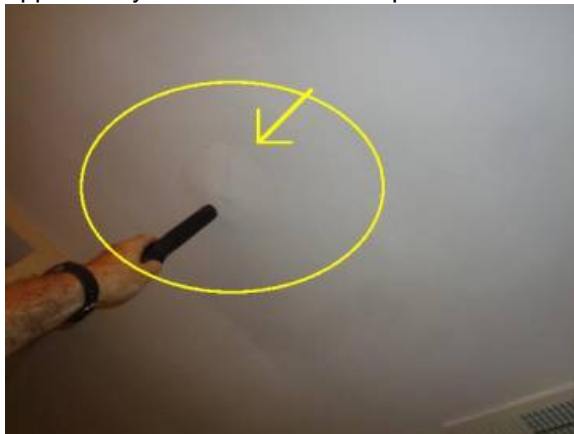
Water damage observed IN THE PAST from a past leaks along the roof. The area appears dry at the time of the inspection. FYI

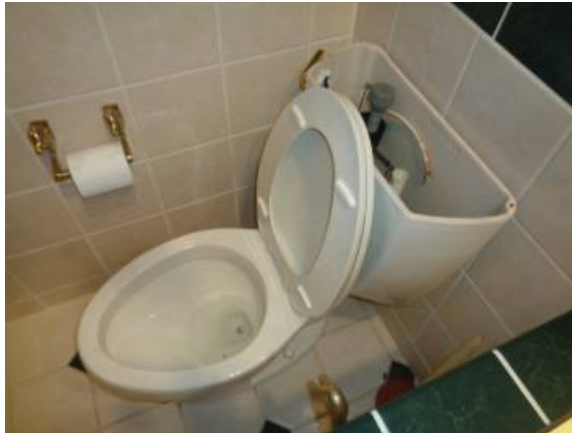
**CONDITION OF TOILET:** The following problems were noted at the toilet: Toilet is loose at floor, Fill valve is worn and needs replacement.

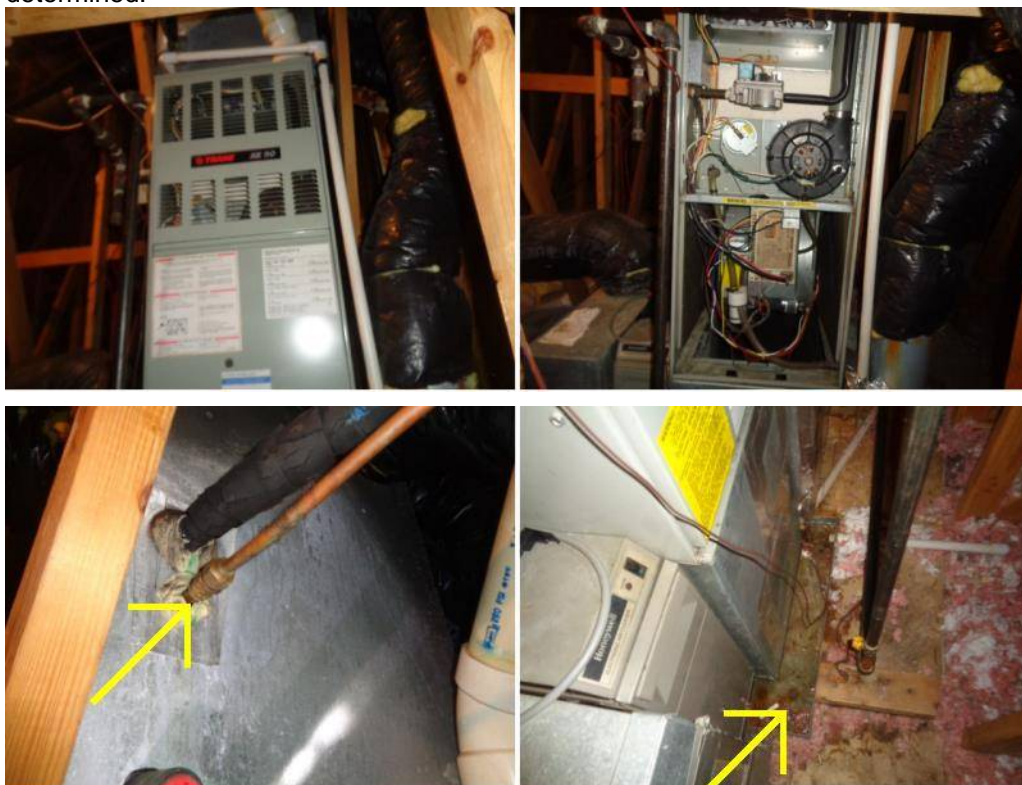
There was water collecting along the pan under the unit the root cause was not determined.
