## AMERICA'S HOME INSPECTION REPORT

**1234 Anywhere U.S.A. Dublin, Ohio 43017**

### A.H.I. Inspection Report

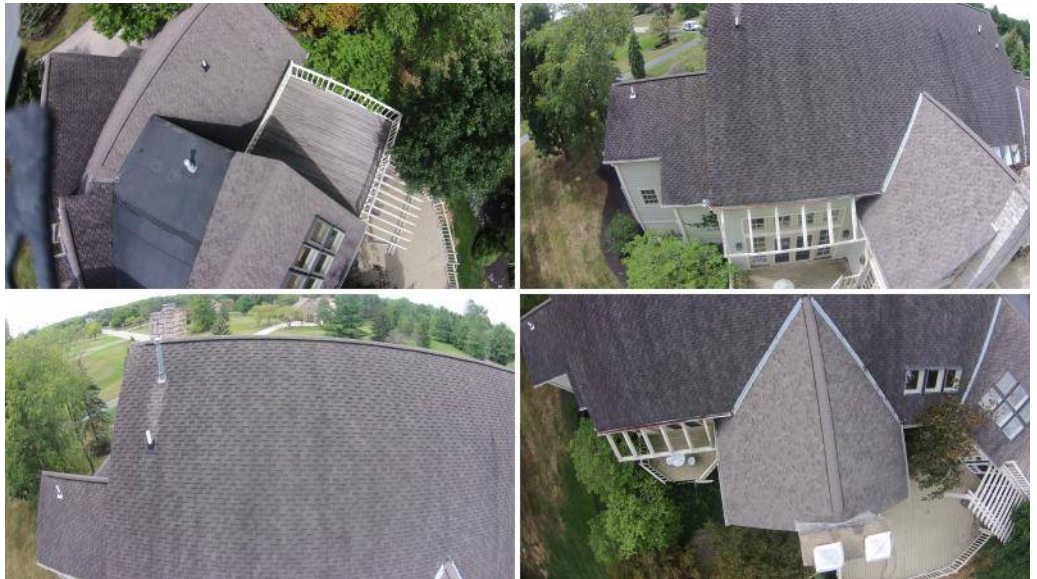
The roof shingles along the front and some areas along the rear side of the house has extensive granulation loss throughout the shingled surface. The granules on the asphalt shingle are what protect the shingle from ultra-violet rays of the sun. Along the rubber roof section I observed areas under the surface that were soft or spongy from likely past water intrusion and below in the ceiling of the loft their also appears to have been past leaks. There were other areas with damage or past leaks along the bathroom upstairs in the bedroom right front. also in the Greatroom ceiling areas were observed.

I observed what appears to be hail damage / Wind along several area's of the roof surface this inspection is not a hail damage assessment however I recommend having the roof looked at further for a second opinion. Contact a qualified roofer of your choice and or check with the seller to have their insurance company follow up. This appears to be the original roof covering I observed several conditions normally observed to determine the life remaining on this roof, A licensed roofing contractor should be called to replace this roof.

The roof cover material is in FAIR overall condition and appears serviceable.

A licensed roofing contractor should be called to make further evaluation and repairs as needed.

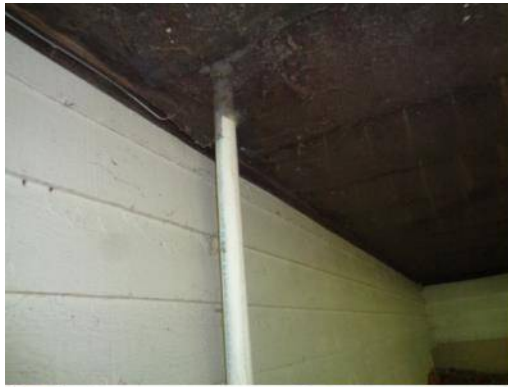
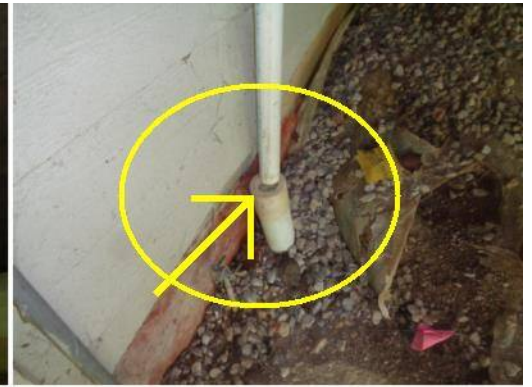
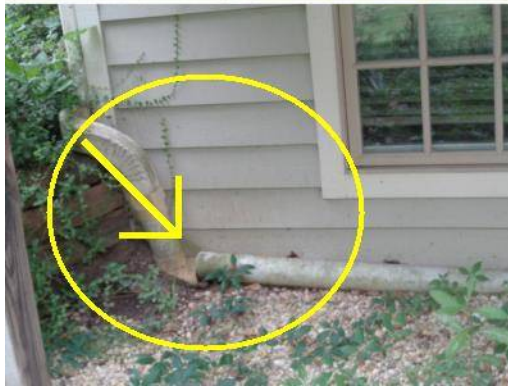
**TYPE & CONDITION:** 2 areas of the drains need reconnected 1 area under the deck and another one along the rear SW corner.

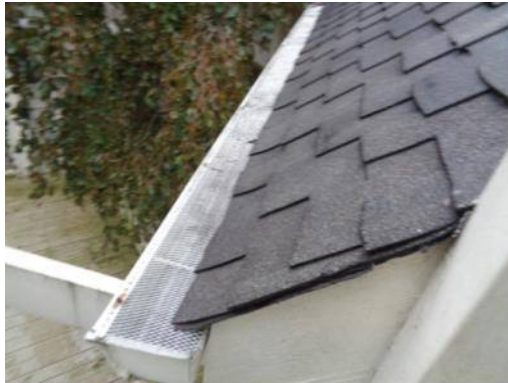
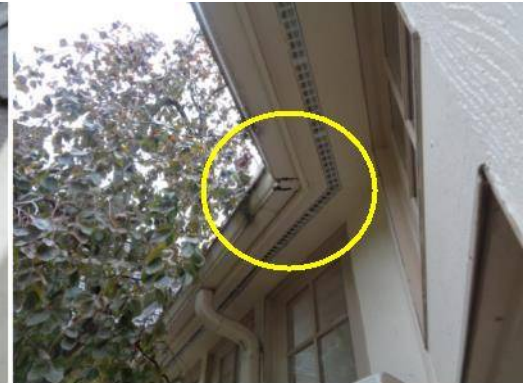
Gutter guards were installed. The gutter just outside the doors in the kitchen was observed leaking, the seam may need re-caulked and sealed.

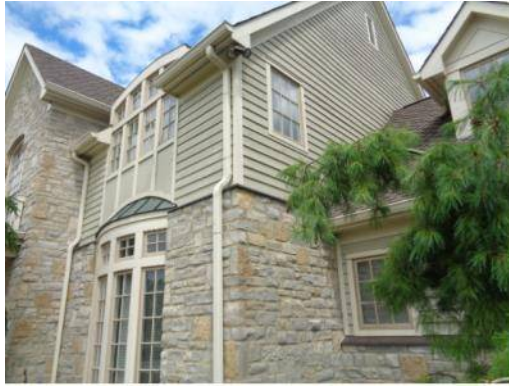
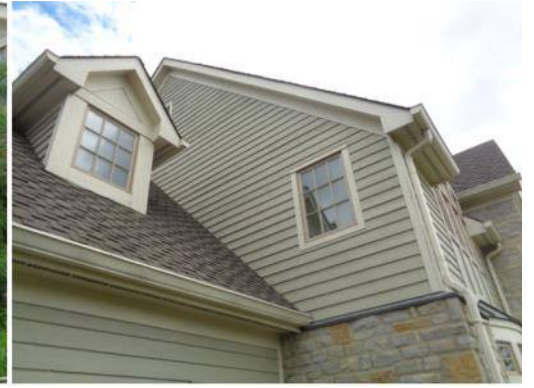
The exterior siding that has been installed on the house will require maintenance in the way of re staining every 7-9 years .

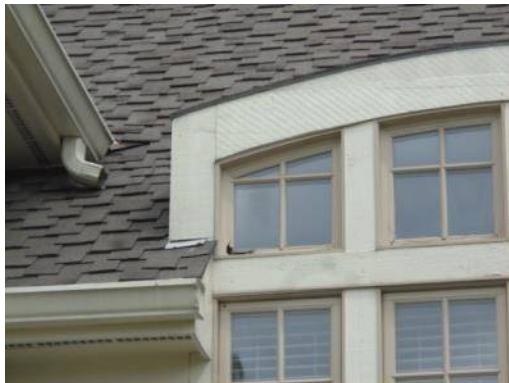
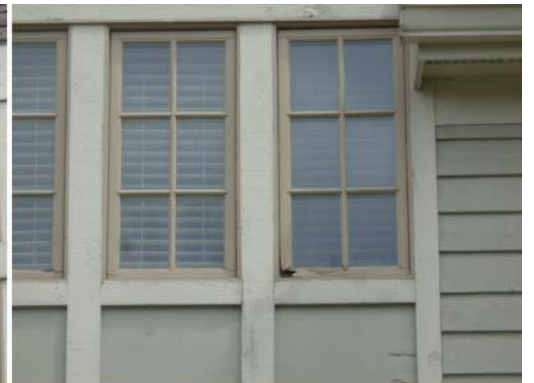
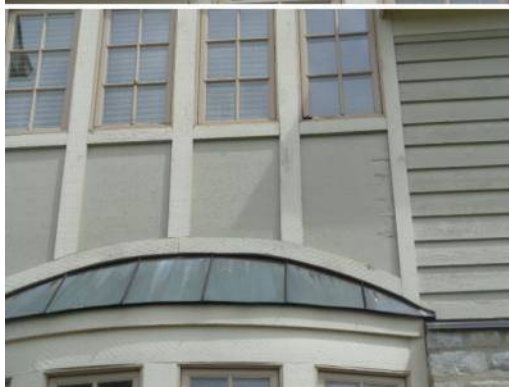
Paint/finish needed:

Areas of the trim were weathered and several areas have wood rot concerns maintenance in the way of re staining the surface to help prevent water penetration and damage to the wood.

SUGGESTION: Repair or replacement of all loose or deteriorated trim and/or siding material will help to protect exposed materials from further deterioration.

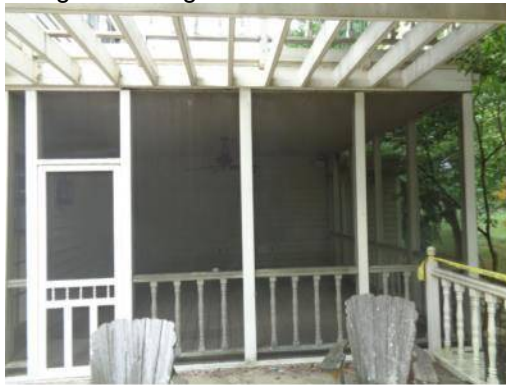
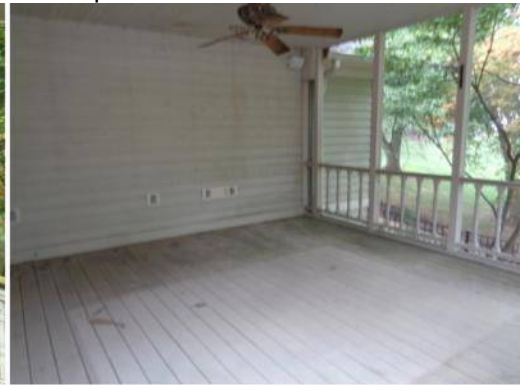
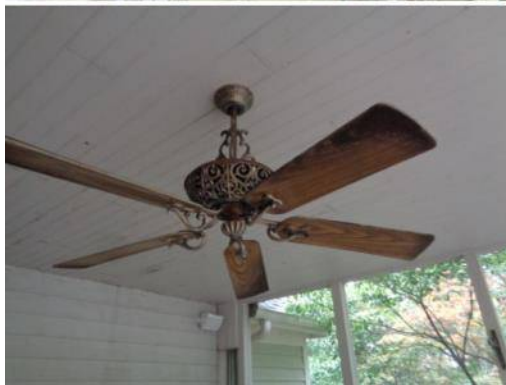
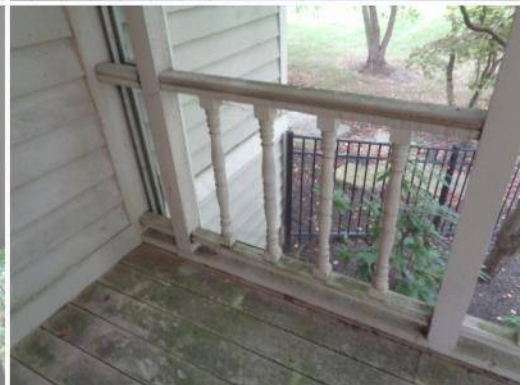
The fan did not work at the time of the inspection. The railing needs replaced and areas along the ceiling had some boards with wood rot repairs are needed.

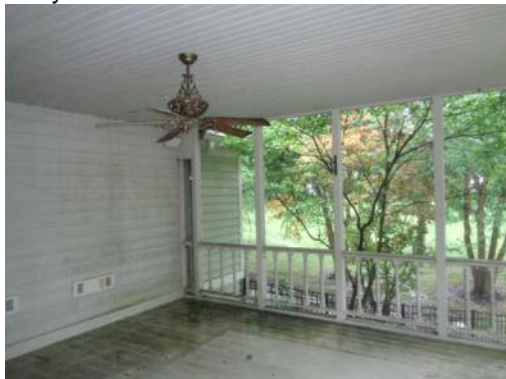
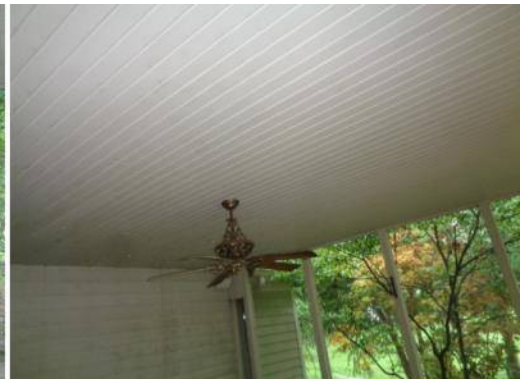
Along the ceiling in the screen room water was observed leaking in several areas this is likely the root cause for the wood rot observed.

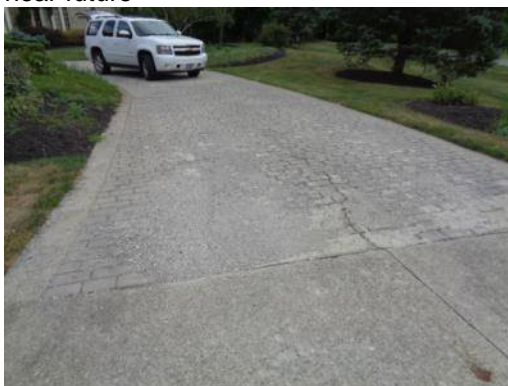
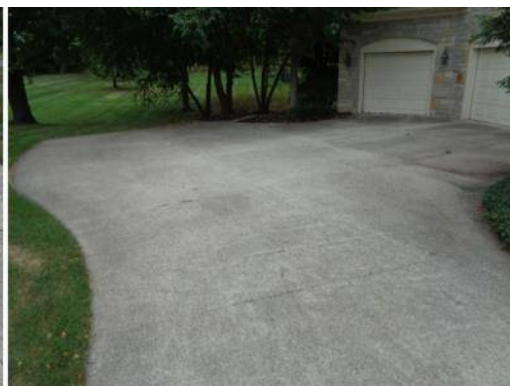
Concrete , Cracks and or deterioration of the surface observed. This condition could lead to further cracking and erosion. Surface is approaching the end of its useful life. Replacement will be needed in the near future

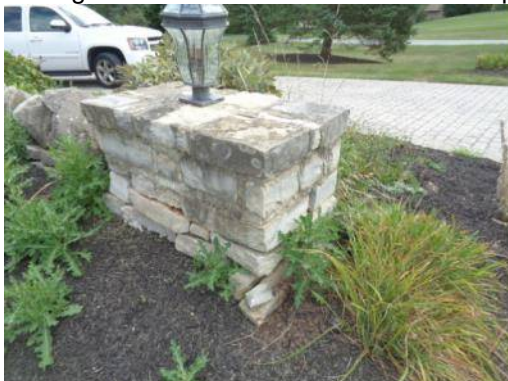
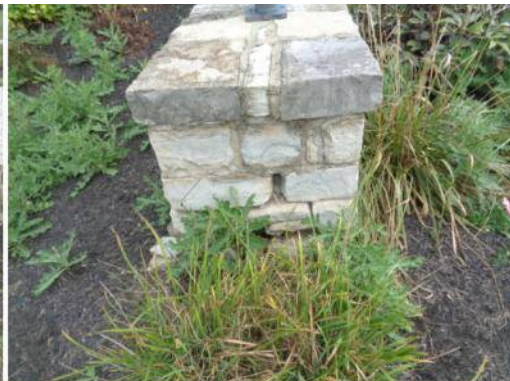
Along all 4 of the stone post several of the stones were loose and mortar was missing between several stones. Deterioration observed. This condition could lead to further damage and deterioration and erosion. Repairs are needed.

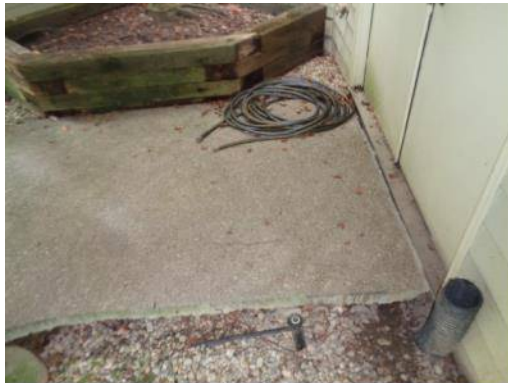
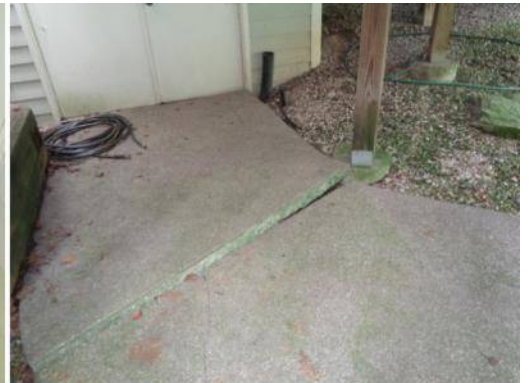
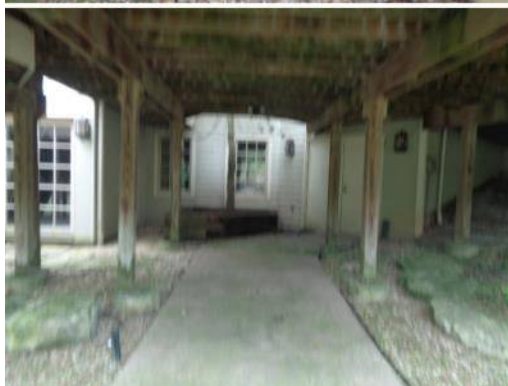
Surface raised/settled along the rear under the deck , repairs are recommended.

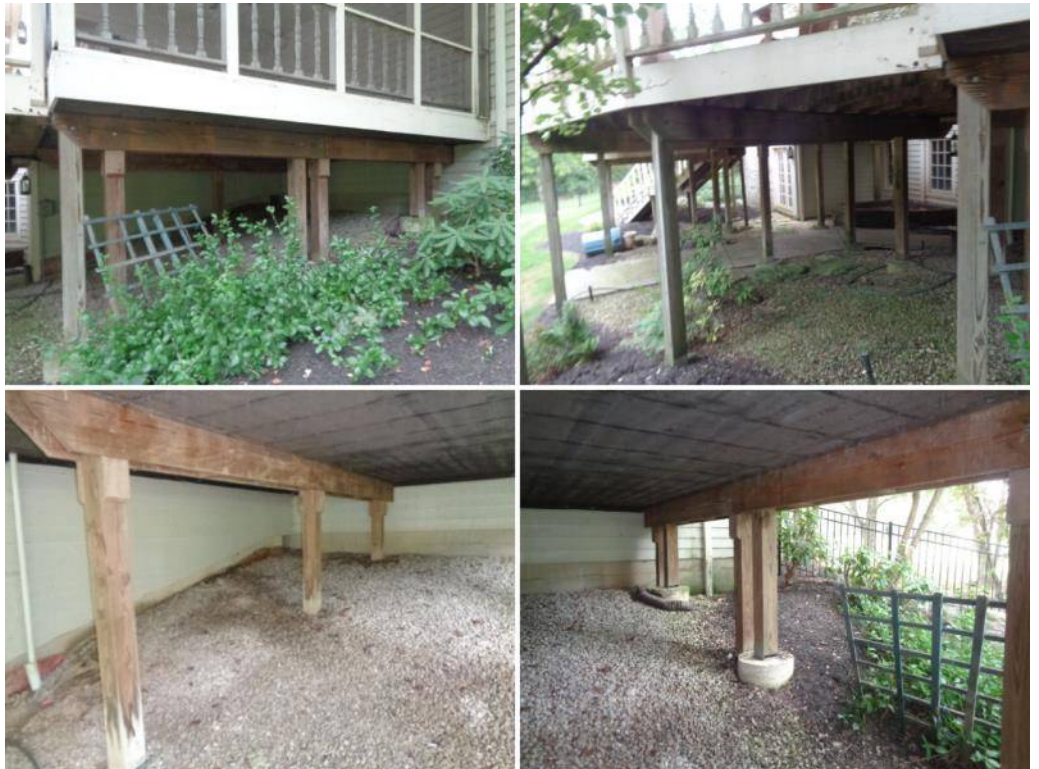
Deterioration noted to areas of the deck surface. The entire railing threw out needs replaced due to the amount of deterioration and unsafe conditions that exist.

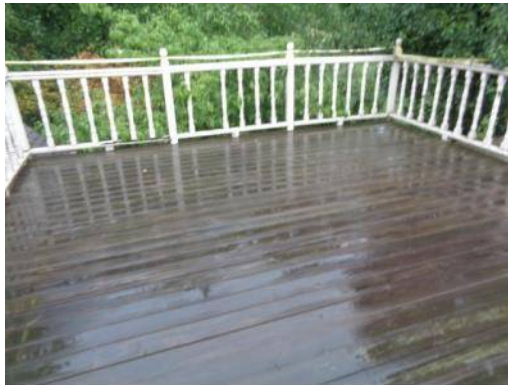
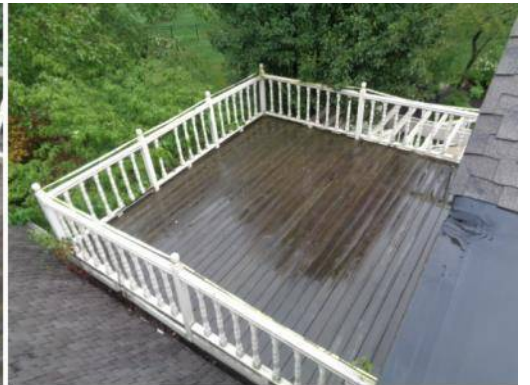
## DECK UPPER DECK :

**CONDITION:** Deterioration noted to deck railing this was consistent threw out the rear decks repairs are needed.

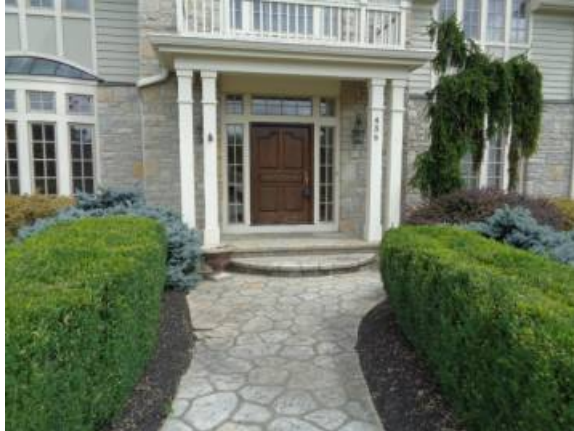
## **PATIO/PORCH COVER:**

**CONDITION:** Appears serviceable

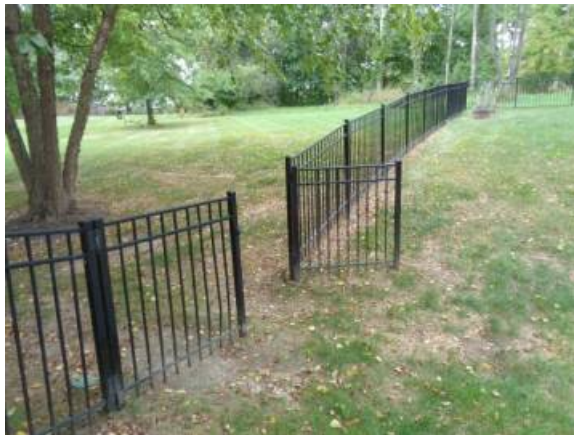
## **FENCES & GATES:**

**CONDITION:** Appears serviceable

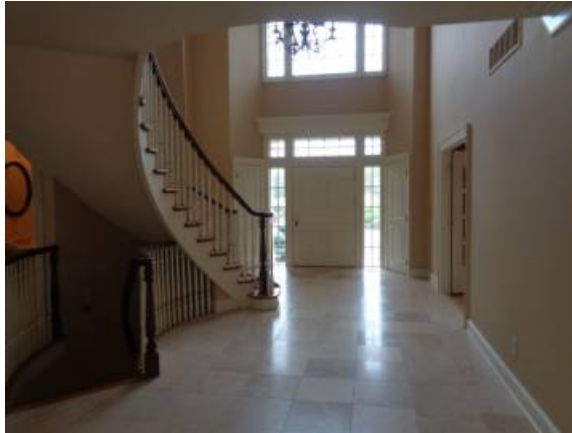
The residence is furnished, and in accordance with ASHI standards we only inspect those surfaces that are exposed and readily accessible. We do not move furniture, lift carpets, nor remove or rearrange items within closets and cabinets. General condition appears serviceable we have evaluated the entry, and found it to be in acceptable condition.

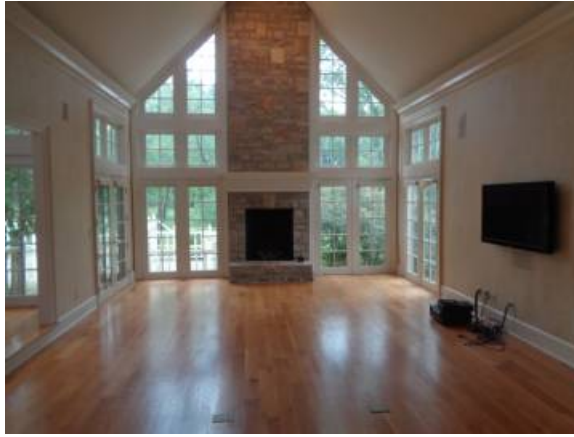
## Great Room / Family Room

Informational Conditions General condition appears serviceable we have evaluated the Great Room, and found it to be in acceptable condition. No recommended service.

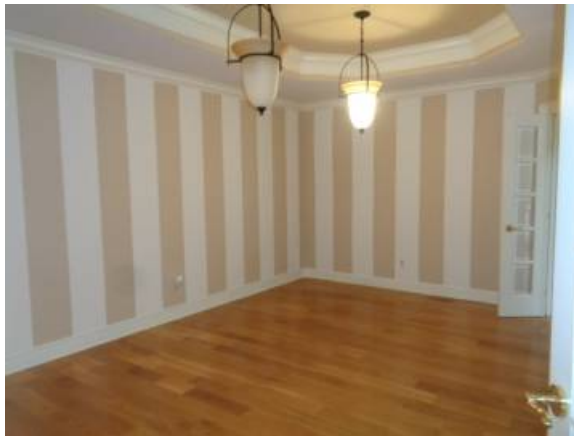
## Dining Room

Informational Conditions General condition appears serviceable we have evaluated the Dining Room, and found it to be in acceptable condition. No recommended service.

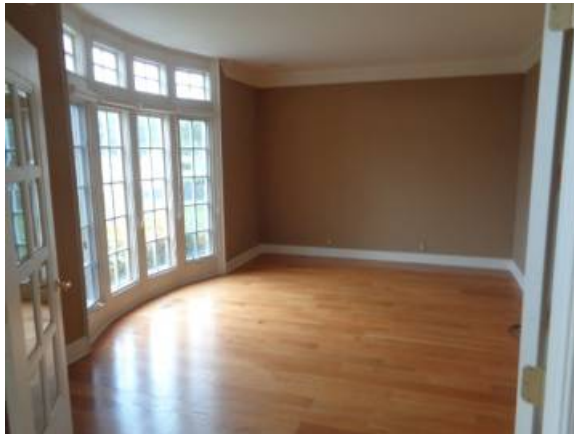
## Office or Library

Informational Conditions General condition appears serviceable we have evaluated the Office or Library, and found it to be in acceptable condition.

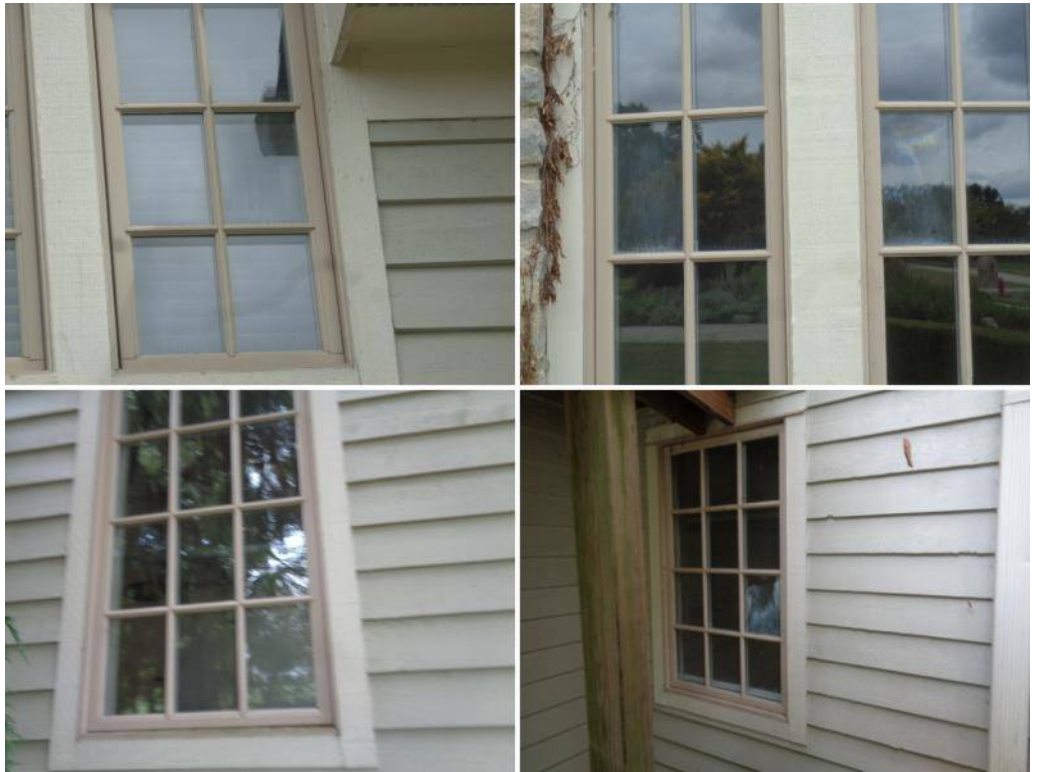
Condensation noted in some window(s) due to failure of seals in dual pane insulated glass unit. Unfortunately, this is not always apparent which is why AHI disclaim an evaluation of hermetic seals.

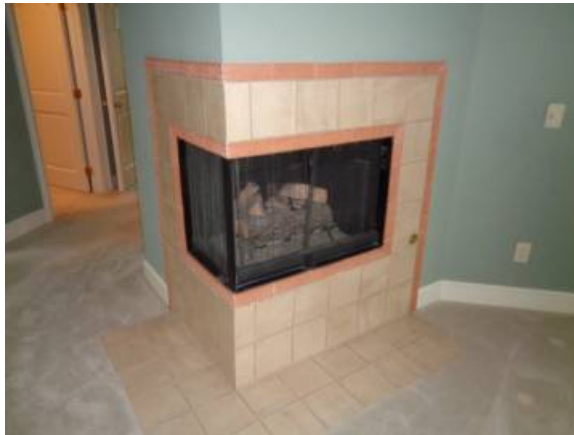
Master bedroom - The gas might be off in the lower basement ?

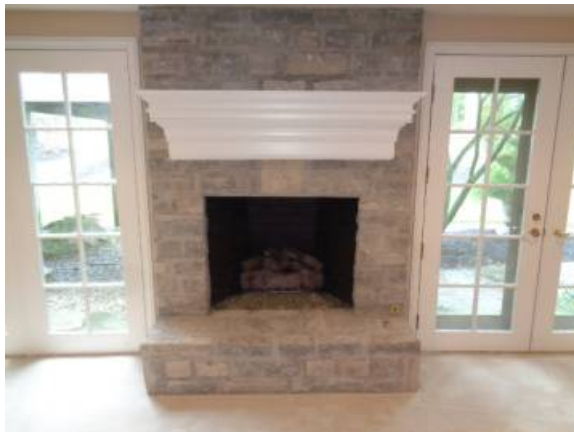
Basement - GAS burning fireplace Damper is operational

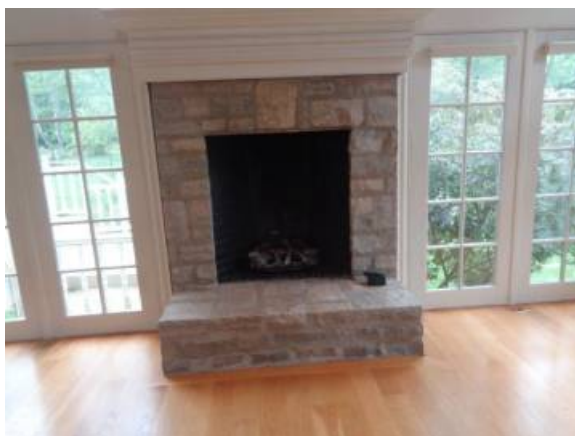
Great room - GAS burning fireplace Damper is operational , The gas might be off in the lower basement ?

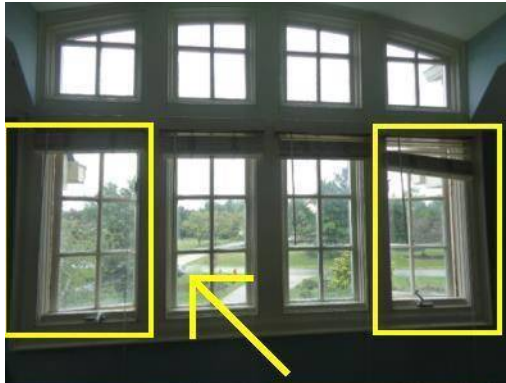
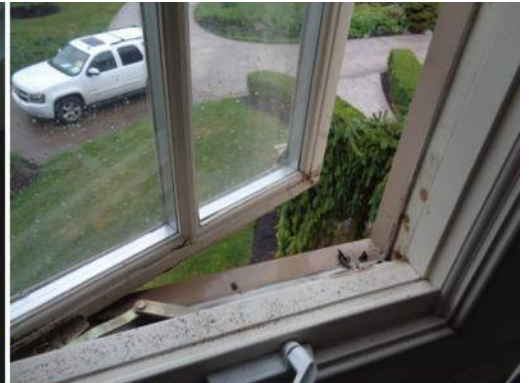
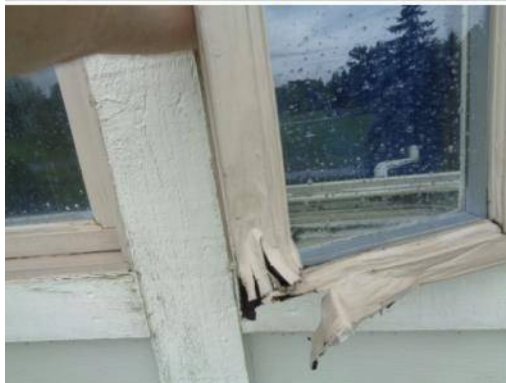
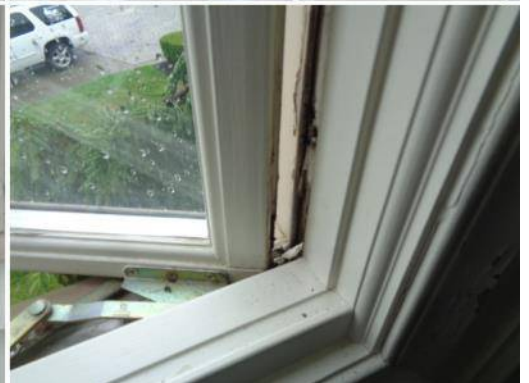
2 windows have wood rot observed and will need repaired or replaced, the lower frames two areas were rotted out. One window noted with a seal failure.

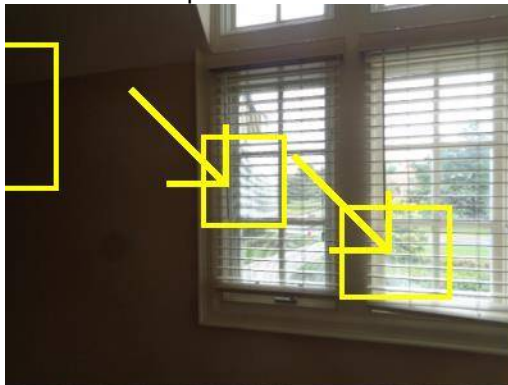
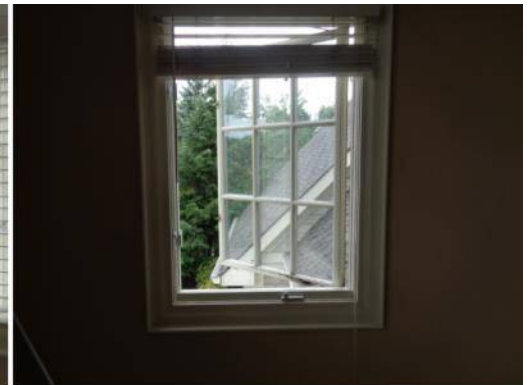
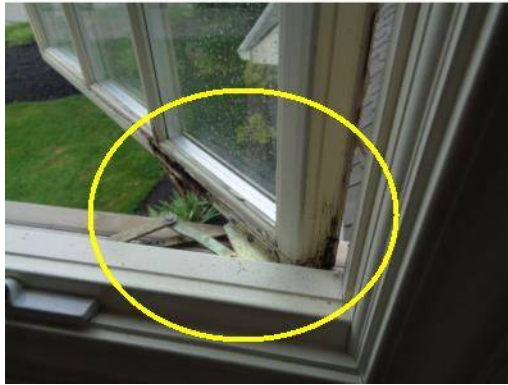
Condensation observed due to failure of seals in insulated glass found in at least 2 windows and the window West wall the lower wood frame was rotted out and needs serviced and repaired.

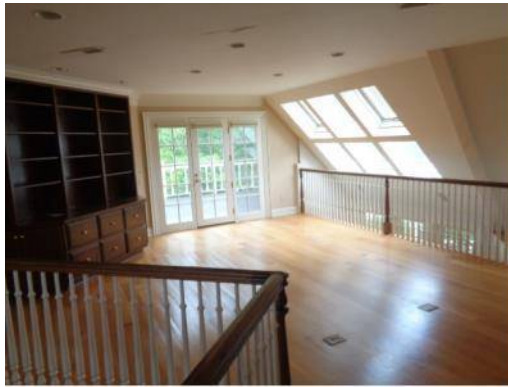
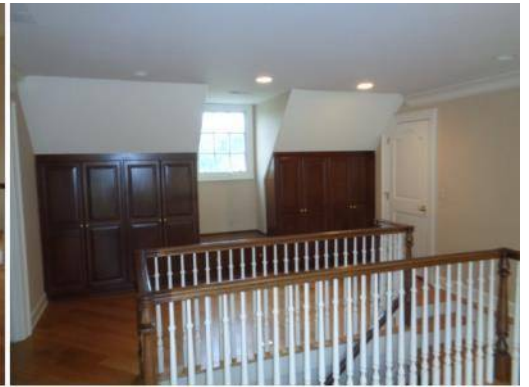
## LOFT : LOFT

Windows were observed to be operational.  
Drywall General condition appears acceptable  
Drywall - Stains noted PAST leaks from the rubber roof was observed .

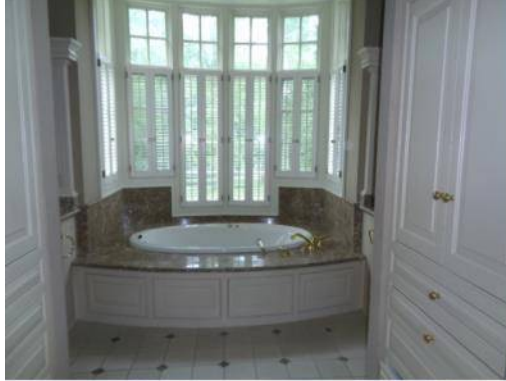
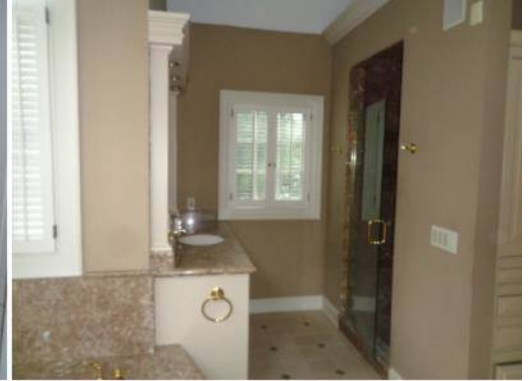
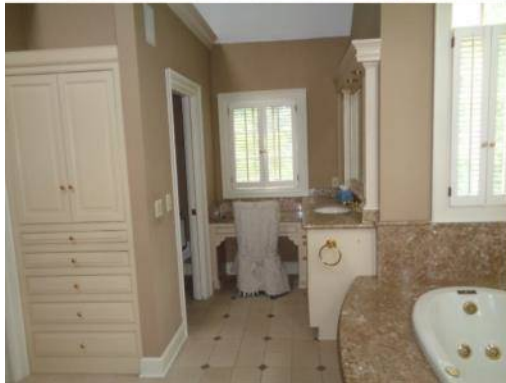
Master bedroom

Condensation observed due to failure of seals in insulated glass front window

One window rear the lock latch was loose and needs re secured the window in front of the chair in the master bathroom.

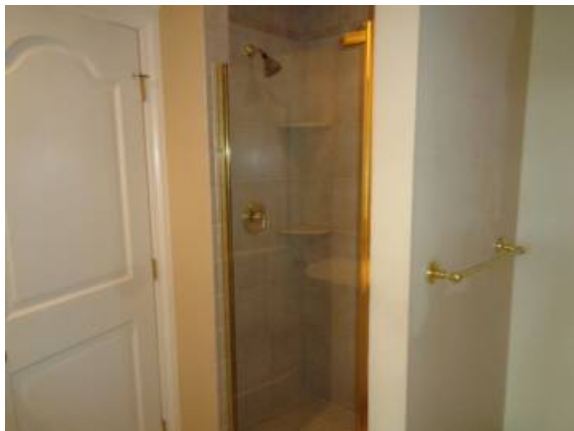
The glass shower door needs serviced and repaired

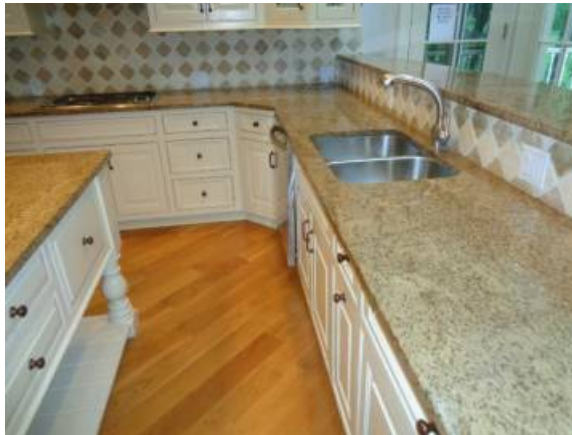
Granite Appear serviceable Cabinets appear serviceable. Note one lower drawer by the double ovens will not push in as something fell behind the drawer and needs removed.

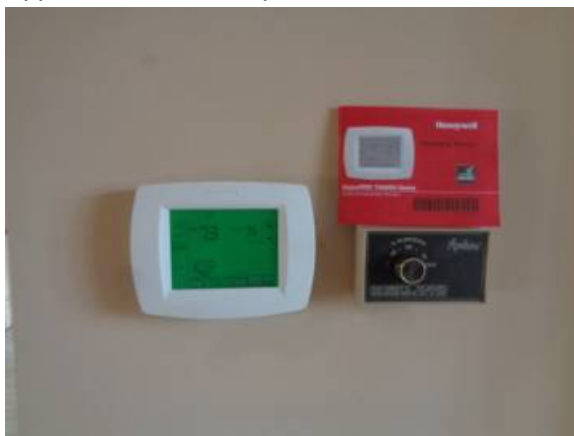
<b>AIR FILTERS:</b>	Suggest cleaning/changing filter - 1. A dirty filter can cause reduced air flow and lower return air temperature . 2. Clogged condensate drain line and condensate flooding. I recommend changing the filter four times a year once every 3 months. When installing the filter make sure the arrow on the filter points towards the furnace for proper installation and air flow. 3M Filters are highly recommended and provide good filtration.
<b>NORMAL CONTROLS:</b>	Appear serviceable upstairs loft area

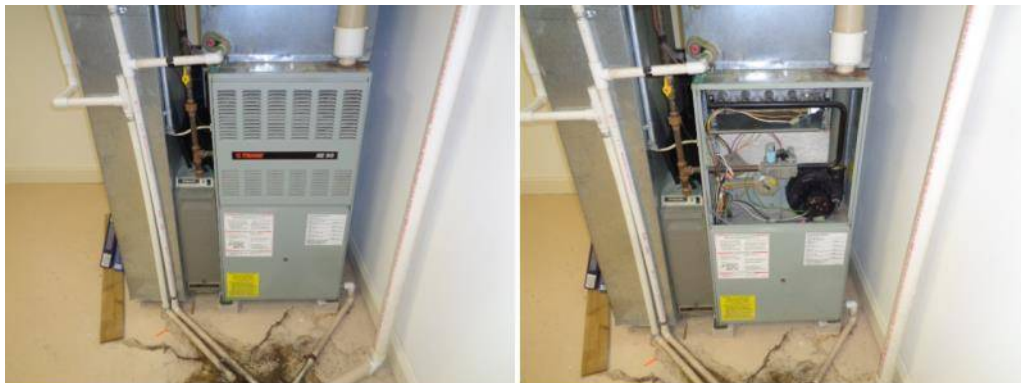
<b>LOCATION OF PRIMARY UNIT:</b>	Basement - Heats and cools the main floor and the lower basement.
----------------------------------	---

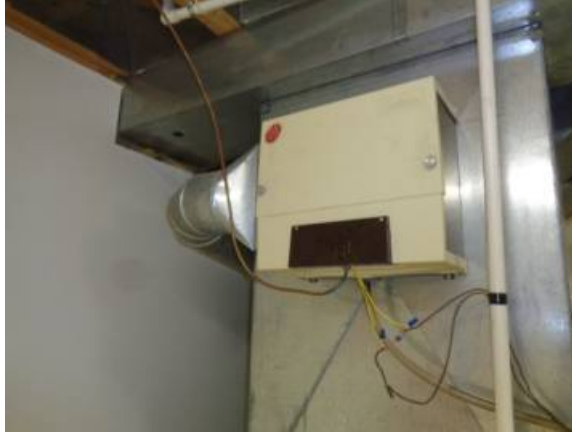
<b>AIR FILTERS:</b>	NOTE: Electronic air cleaners and humidifier are beyond the scope of this inspection. The electronic or electrostatic air filter contains a series of fine wire grids that are given an electrostatic charge, which aids the filter in capturing small particles of dust, smoke, and pollen. When the filter is working, it pops and crackles like a bug zapper.

**NORMAL CONTROLS:** The controls are in the dining room .
